Known Issue: KH T-bar Mounting Bracket

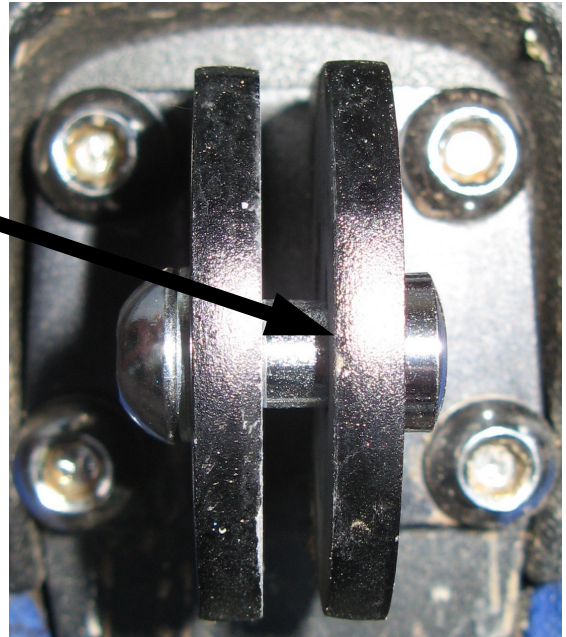
The barrel of the slotted insert is hitting the other L-bracket, preventing proper tightening of the plate on the slotted tube.

Solution: the hole for the hex bolt needs to be re-drilled to 8 mm diameter (or 5/16").

This is the same diameter as the hole on the other L-bracket.

This allows sufficient room for the barrel on the threaded insert to tighten properly.
